ENVIRONMENTAL GEOLOGY NOTES

JULY 1976 • NUMBER 76

*Bluff Erosion,
Recession Rates,
and
Volumetric Losses
on the Lake Michigan Shore in Illinois*

Richard C. Berg and Charles Collinson

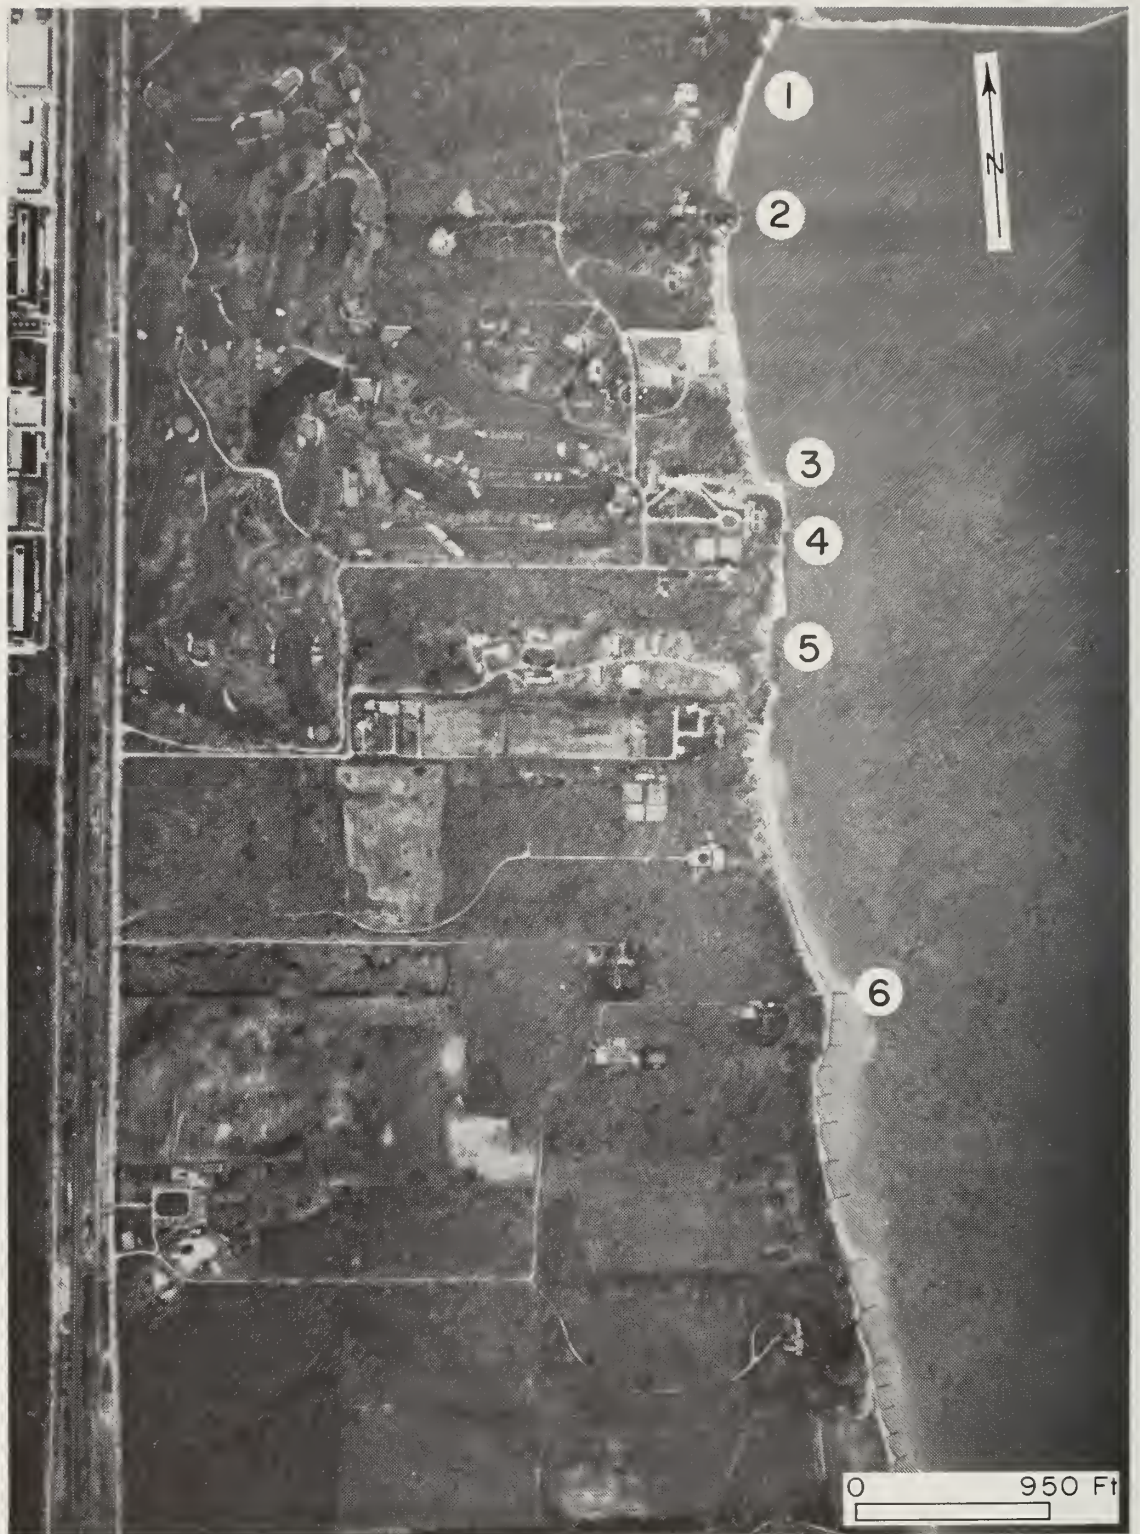
5—Area previously protected by groins but now exposed to wave and current effects.

6—The north end of an effective groin field. Note the light-colored currents by-passing the jetty and the clay-laden waters passing southward along the southern shore.

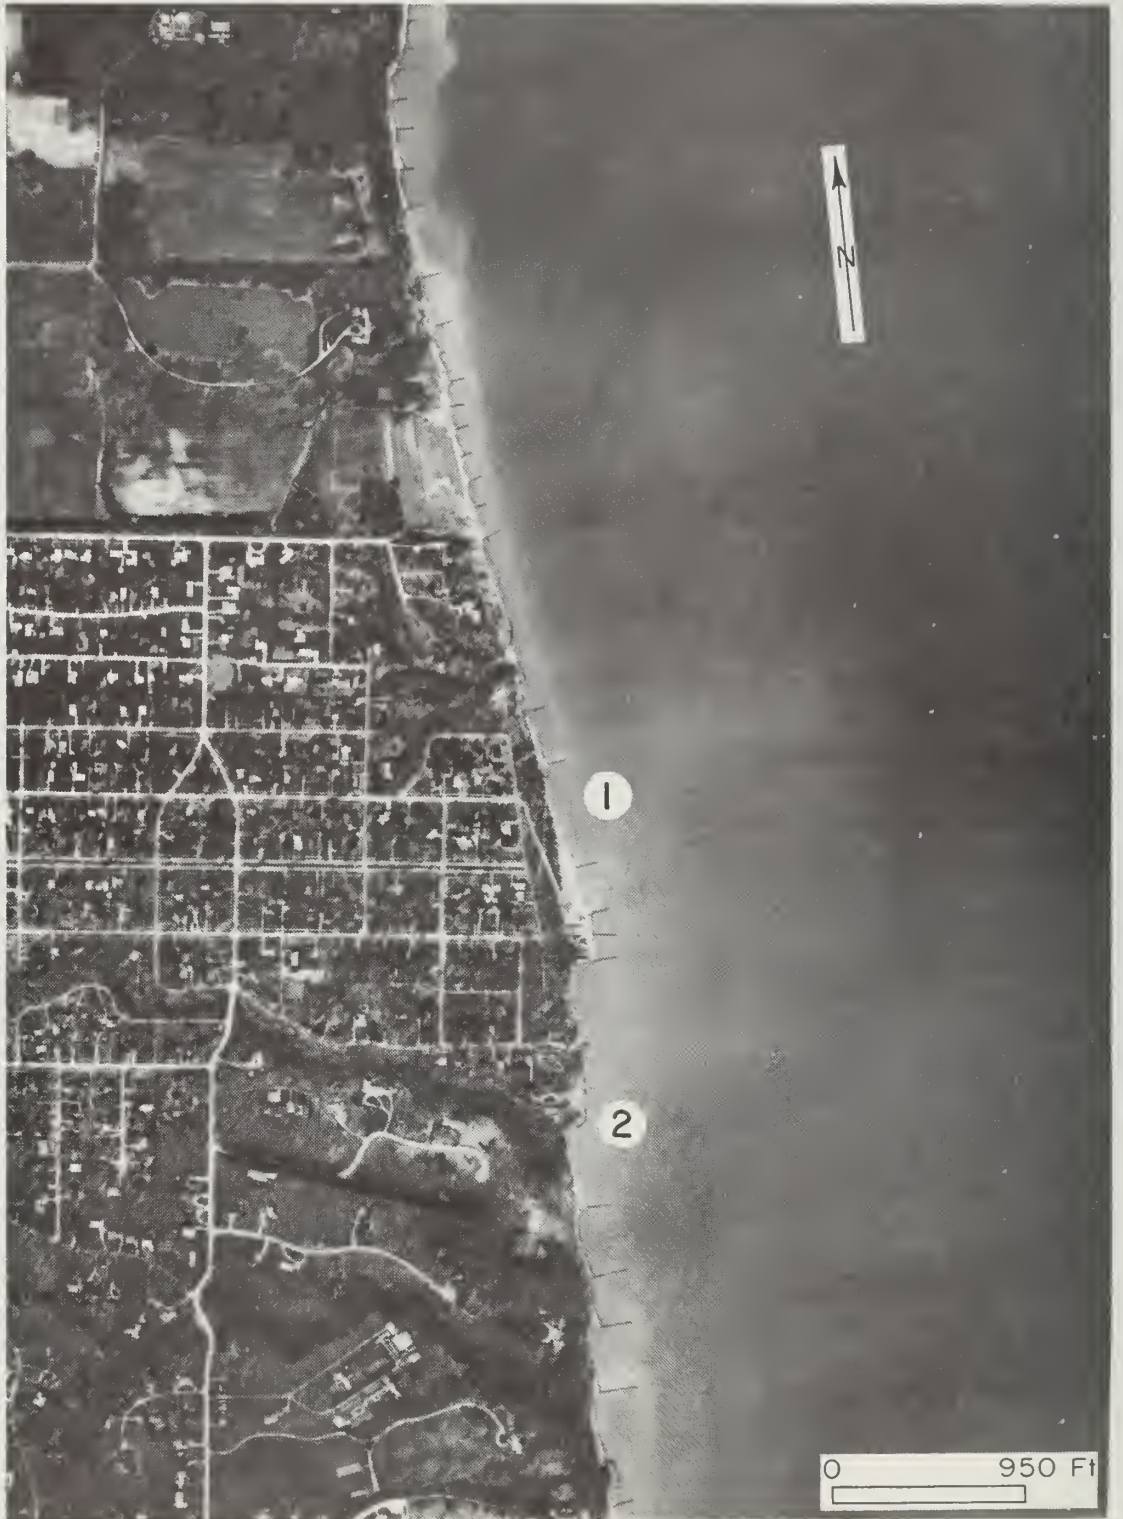
Fig. 7 - Reach of shore covering central Lake Bluff from Arden Shore at the north to Lake Forest Cemetery at the south.

- 1—The well stabilized reach north of and adjacent to the Lake Bluff Sewage Disposal Plant. The area is protected by groins and bulkheads. See also figure 4.
- 2—The site at which a bulkhead failure caused severe erosion of the bluff for approximately four years (fig. 14). The areas immediately north and south, protected by bulkheads, have remained relatively stable.

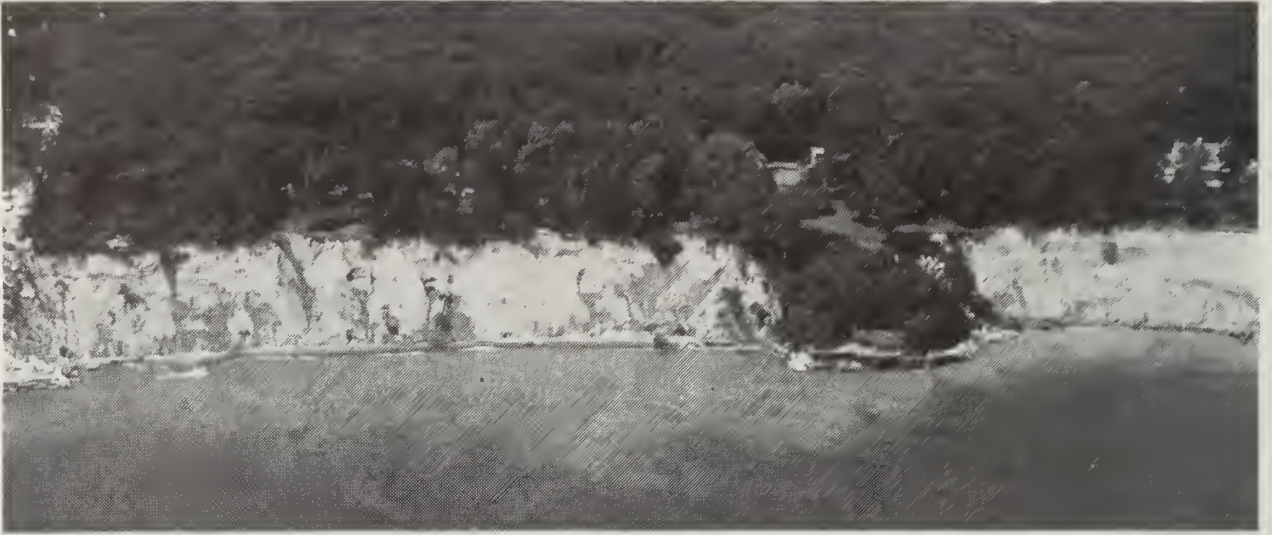
Fig. 11 - Bluff one-eighth of a mile south of Great Lakes Naval Training Center, August 1974, at a lake level near 580 feet. The bluff is more than 70 feet high. The lower part is of homogeneous gray glacial till. Most of the upper half of the bluff consists of weak till, silt, sand, and gravel. The beach house was built before 1947 and has been maintained ever since. Its location indicates the subsequent bluff recession (fig. 5). Numerous seeps can be seen along the entire reach. Fallen trees can be seen on the bluff face and on the narrow beach. More moisture is present below the mouths of truncated gullies than elsewhere. Rubble groins once present along this shore have been damaged and submerged. This location is shown by a vertical aerial view in figure 6.
